FACILITY STATUS CHANGE FORM

Date Submitted: November 6, 2013 Originator: Chris Strand Phone: 554-2720	Area: 300 Area Facility ID: 3760, 323BA Action Memorandum: Action Memorandum #3	Control #: D4-300-092
---	---	---------------------------------

Attachment 1: Facility Information

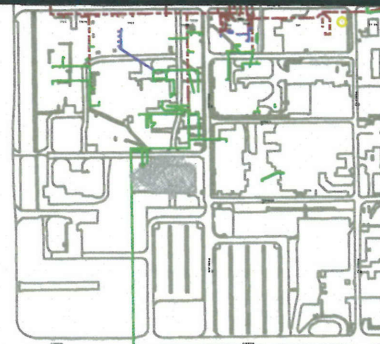
300 D4 3760 and 323-BA GPERS Radiological Survey Beta Track Map

No anomalies were discovered during the below-grade removal of both the 3760 and 323BA foundations. A visual inspection conducted on 10/30/13 identified no soil staining within the excavation. GPERS surveys (Attachment 3) identified no radiological contamination. The common excavation was backfilled with clean fill material.

Coverage File: D4_303A
Number of Data Pnts: 362
Type of Survey: beta
Max GCPM: 622
Avg Bkg CPM: 362
Survey Date: 10/30/2013
Area Surveyed: 3,080 m²
Project File: ESRFRM130065B
Pdf File: ESRFRM130065BC
